Issue Date:	June 27, 2017	File:	2016.4876.000
To:	Landmark Planning & Design Inc. / EdgeEffects Environmental Planning		
From:	Jeff O'Driscoll, P.Eng., IRP		
Client:	Mid-West Planning District		
Project Name	Development Plan Review		
Subject:	Engineering Background Study

TECHNICAL MEMORANDUM

TOWN OF BIRTLE
 ENGINEERING BACKGROUND STUDY

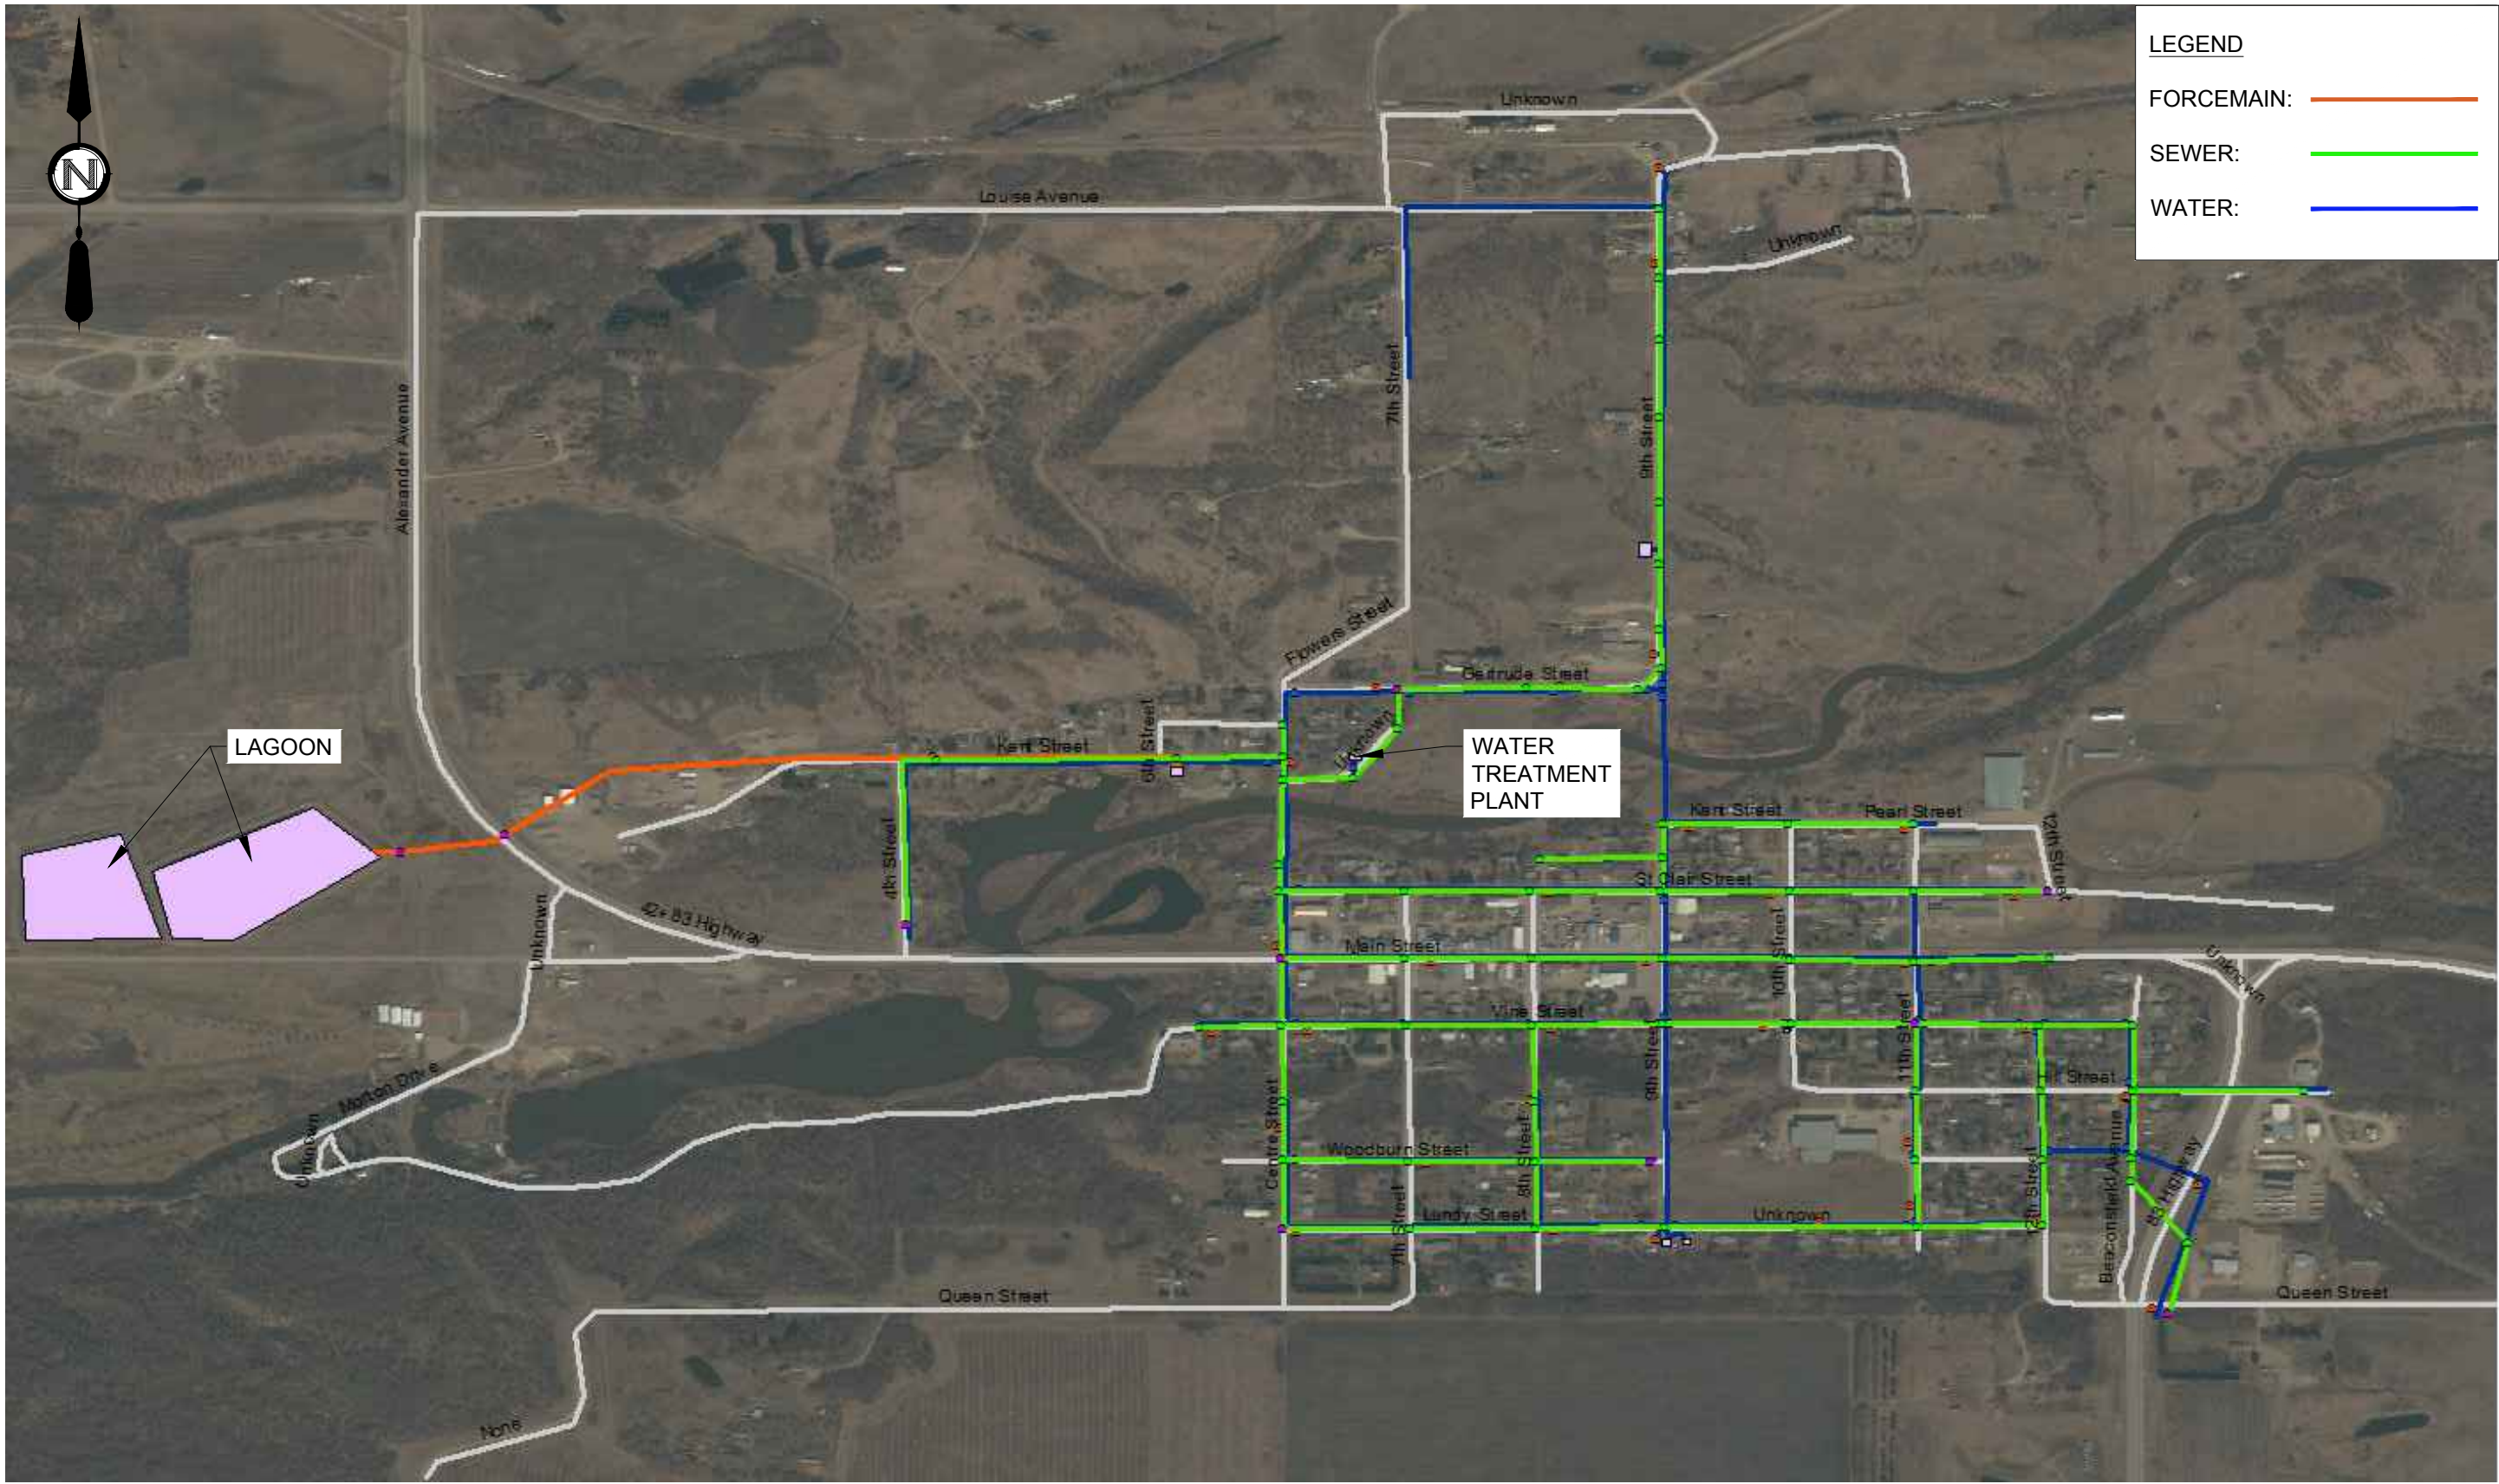
FIGURE 1

The Community of Birtle's municipal water system provides residents with potable water for both domestic and fire fighting capability through hydrants located in the community. Raw water is taken from wells, treated, stored and piped throughout the community. The water treatment system has been characterized as being in poor condition and requires upgrading. A boil water advisory was issued by the Province in May 2017. The community is investigating alternate groundwater supplies and the development of a new water treatment plant to replace the existing facility. The water system upgrades will allow for future growth and extension of services in the community (Source: The Manitoba Water Service Board, Town of Birtle, Water Supply Feasibility Study, W.L. Gibbons and Associates, December 2014; Municipality of Prairie View, Water Supply Feasibility Study, Hoppers Lake Area Groundwater Investigation, W.L. Gibbons and Associates, August 2016). In April 2017, funding (Federal/ Provincial) was announced related to the project. Reference Figure 1 for details on the existing water, sewer and lagoon locations.

A municipal sewage collection and treatment system services the community. Sewage is collected by gravity into a main lift station which pumps wastewater to a two-cell facultative lagoon located west of the community on NE 1-17-27 WPM. The lagoon is experiencing capacity issues as reported by the Province of Manitoba (including, but not limited to hydraulic capacity, sludge volume, etc.). The community is conducting a capacity study to review mitigation measures for compliance. The current condition of the facility does not support the expansion of services in the community.

- Gravity wastewater collection system with lift station
- A two-cell lagoon is located west of the community
- The lagoon does not include truck haul receiving facilities
- The lagoon is experiencing hydraulic capacity issues, which is possibly attributed to high sludge volume
- Land is available north the existing lagoon cells that could be considered for expansion
